Evaluation of USCG Cutter Point Francis Propeller Strike on Right Whale Calf

Field Number: RKB-1424

March 9, 2005

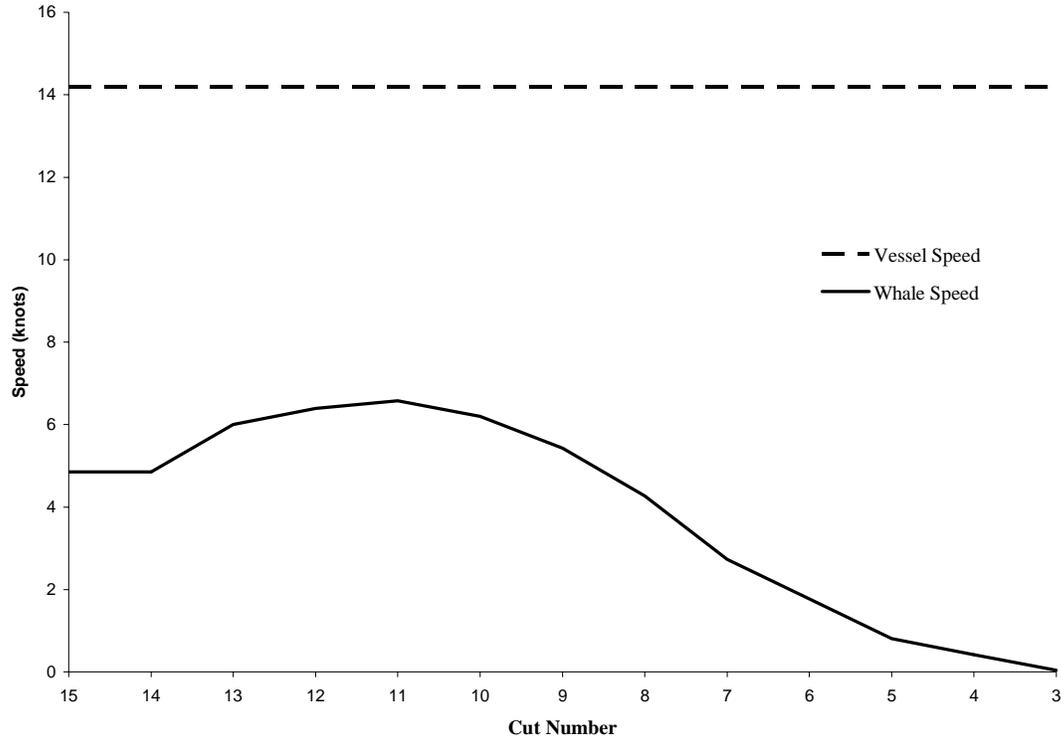
Based on this evaluation of the propeller cuts, the whale and the Point Francis approached each other head-on (Figure-9), and only one propeller of the Point Francis struck the whale. This strike created propeller cut Series I (Figure-2). It appears that the whale was submerged as it approached the vessel. The full length of the vessel's hull probably passed directly over the whale before it was struck by the propeller. The whale's speed (Figure-1) at the beginning of the strike was about 4.8 knots. This does not indicate any flight response from the whale. The whale's speed increases to 6.8 knots

at Cut #11. This may well be the result of a reflex reaction of the whale resulting from the initial propeller strikes. After Cut #11, the whale apparently becomes incapacitated and its speed drops to 0 knots at Cut #3. According to the necropsy report, the cuts created by the Point Francis were very probably the cause of death, and this evaluation supports that conclusion.

Figure-1: Plot of whale's speed at each cut in Propeller Cut Series I

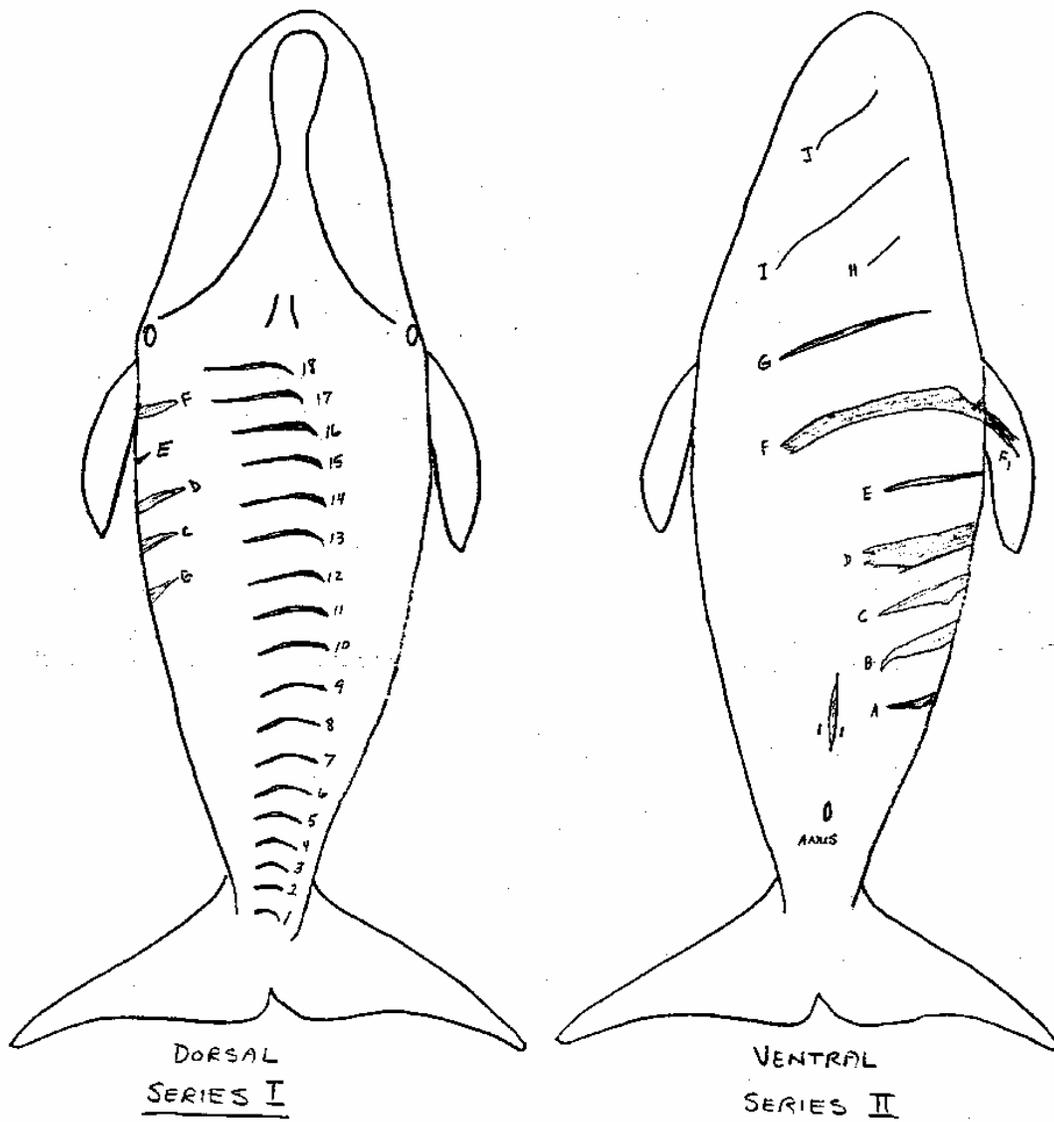
Drawings from Necropsy Report RKB-1424

The drawings of the propeller cuts included in the necropsy report (Figure-2) provide a reasonable approximation of the position and character of the propeller cuts visible in photographs of the carcass. The drawing of propeller cut Series I depicts a set of some 18 evenly spaced cuts along the dorsal surface of the animal. The drawing of propeller cut Series II depicts a set of some 9 more or less evenly spaced cuts along the left side of the carcass and across the ventral surface. The separations between successive cuts in Series II are significantly larger than the separations between successive cuts in Series I. Also, individual cuts in Series II are generally longer than the cuts in Series I. These observations can be confirmed by referring to the Table of Measurements from the Necropsy Report (Figure-3). The two series of cuts have distinctly different visual characteristics.

Figure-2: Original drawings from the Necropsy Report RKB-1424

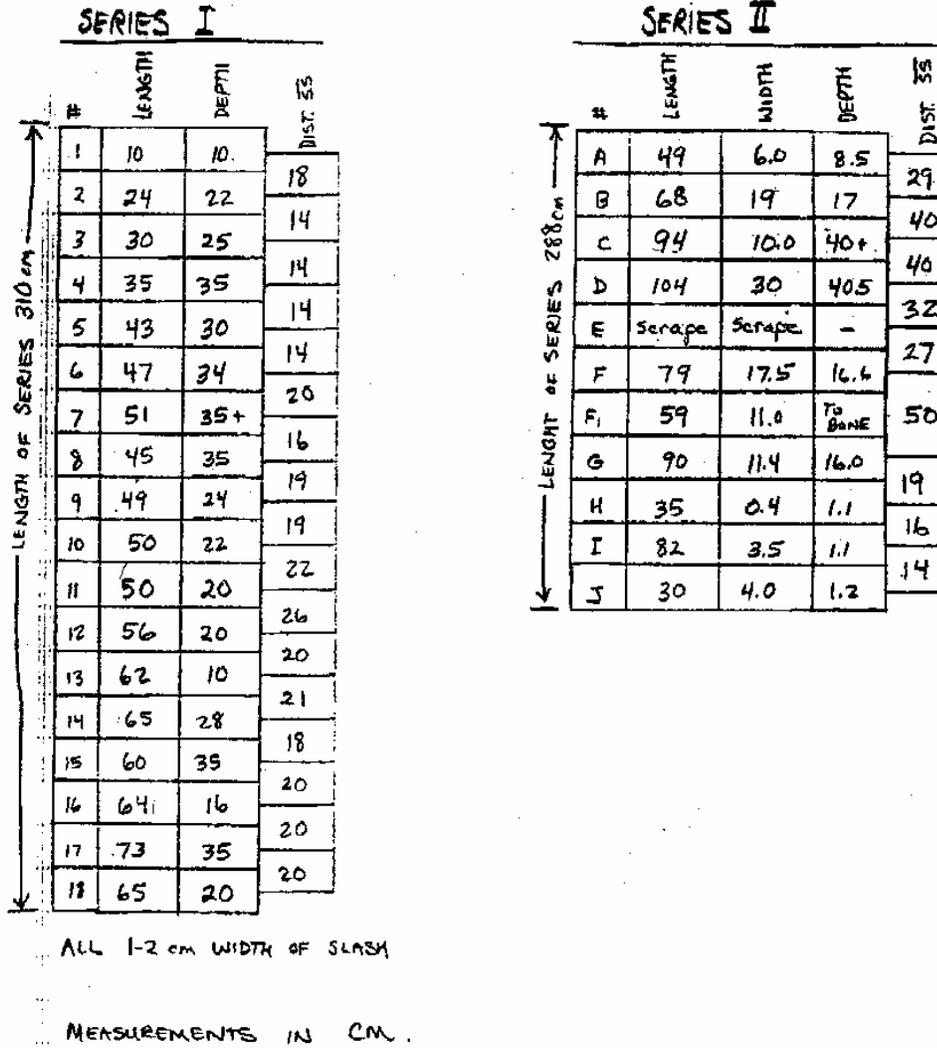
Table of Measurements from Necropsy Report RKB-1424

None of the photographs of Propeller Cut Series II are suitable for detailed analysis. However, it is possible to use the length of the cuts recorded in the Table of Measurements (Figure-3) to determine that the propeller which created these cuts was at least 139.5 cm (55 inches or 4.6 feet) in diameter. Calculations using the length and depth of the cuts indicate that the propeller was possibly 247 cm (108 inches or 9 feet) in diameter or larger. Both of these methods usually underestimate the diameter of the propeller by a significant margin. A third calculation indicates that the propeller was approximately 484 cm (191 inches, 16 feet) in diameter. Without more suitable photographs of the cuts in Series II it is only reasonable to state that the diameter of the propeller was certainly larger than 139.5 cm (55 inches) and may have been significantly larger than 247 cm (108 inches). Clearly, these cuts were not created by the Point Francis.

Figure-3: Table of Measurements from the Necropsy Report RKB-1424

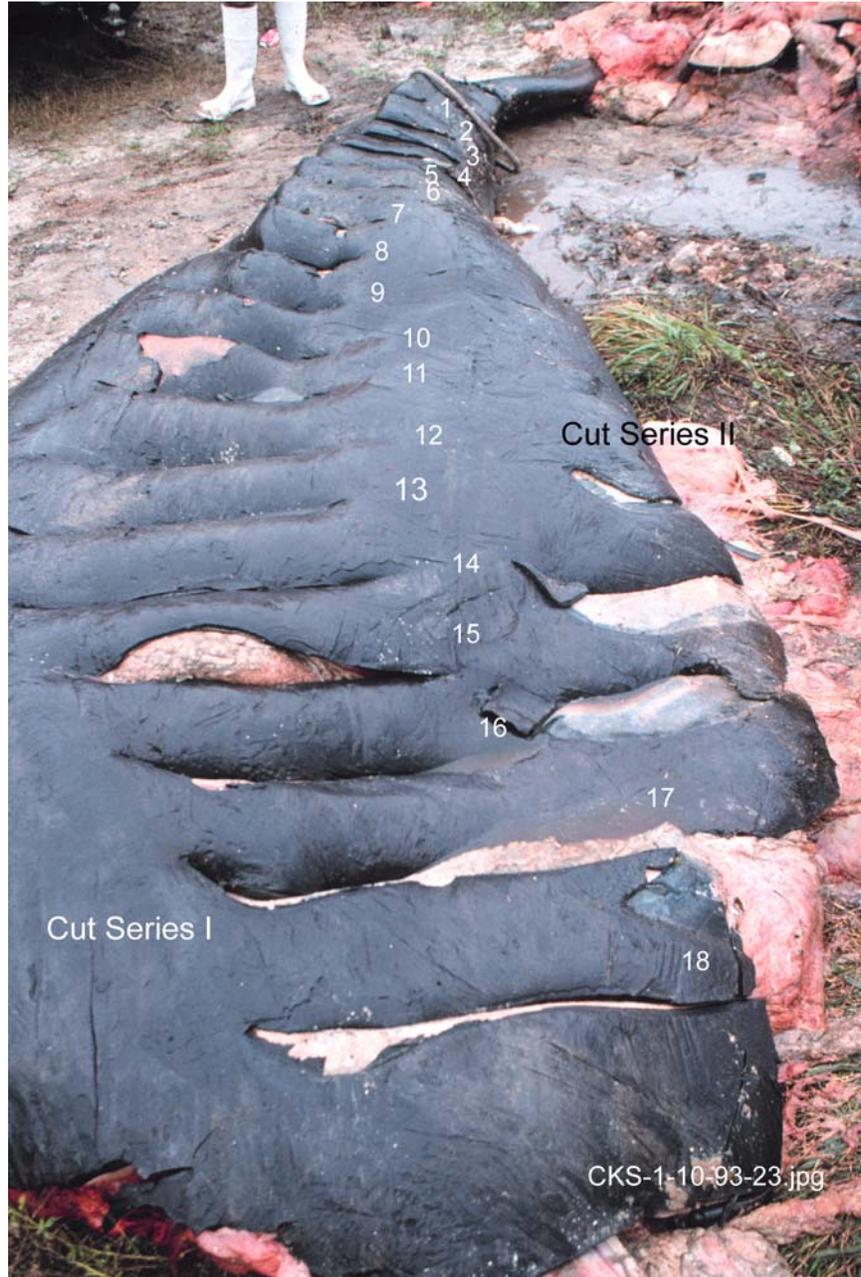
A photograph of the cuts in Series I (Figure-4) was selected for analysis using unpublished methods developed by this author. Specifically, the analysis was conducted on Cut #13. In this case, Cut #13 was selected because it was the most suitably rendered cut in the photograph. Any cut in the series can be used for this analysis if the series of cuts has been photographed properly. Though a detailed explanation of the methods employed is beyond the scope of this evaluation, the results provide an interesting insight into the specifics of the accident.

The maximum length of cut that each of these propellers could reasonably create was used to eliminate the propellers with 3 and 4 blades. The cord depth that each of the remaining two propellers would produce for each of the cuts in Series I was used to eliminate the propeller with 6 blades. Therefore the cuts in Series I were most probably created by a 114.6 cm (45 inch) diameter propeller with 5 blades. This calculated size is within 7% of the actual size of the propellers on the Point Francis. The method of

Figure-4: Propeller Cut Series I – Cut #13 was used for detailed analysis. Propeller Cut Series I is to the left of the photograph, and Propeller Cut Series II is to the right.

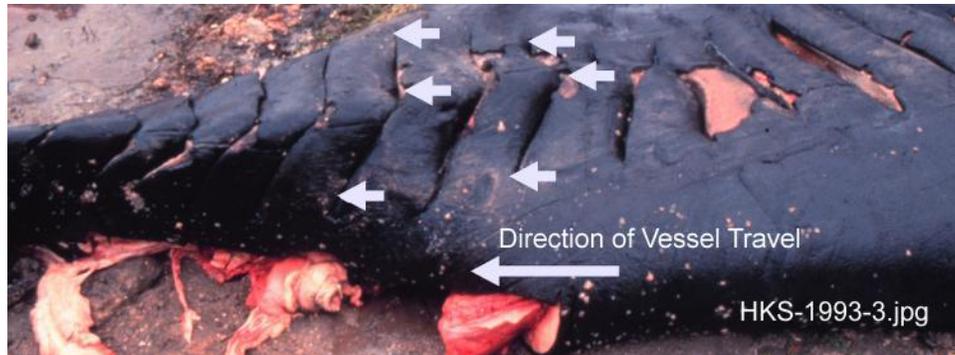
The direction the vessel crossed the animal's body can often be established by examining the shapes of the individual propeller cuts, however there are instances when these shapes can be misleading. The cuts in Series I are an example of just such a case. The drawings of the propeller cuts taken from the necropsy report (Figure-2) provide a reasonable approximation of the shape of the cuts in Series I. Most of these cuts, and especially the cuts along the dorsal caudal ridge, form a crescent shape that would normally be interpreted as indicating the vessel advanced from the tail to the head. Unfortunately, the use of the crescent shape of the cuts as an indicator of the direction of the vessel's advance is only valid when the cuts are very shallow.

Most of the cuts in Series I occur on relatively narrow body sections which results in cuts that are almost as deep as they are long, and when combined with the significant rake angle of the propeller on the Point Francis, this produces cuts with entry and exit points that are well forward of the center of the cut (Figure-5). This creates a geometry which has been appropriately described as the "sliced pickle effect" (Pitchford, 2002). These cuts form a crescent shape which would imply that the vessel was traveling in a direction directly opposite its actual direction of travel. Therefore, only the shapes of very shallow cuts that occur on broad, relatively flat surfaces should be used to establish the direction the vessel traversed the surface, and none of the cuts in Series I are suitable for this purpose. The position and shapes of the cuts do reveal that the propeller was rotating clockwise.

Figure-5: Propeller Cut Series I – The shape of these cuts gives a false impression of the direction the vessel traversed the surface of the animal. Entry and exit points (identified by the arrows at each end of the cuts) are well forward of the center of the cut (identified by the arrow at the center of the cut). The actual direction of the vessel travel is indicated by the large arrow.

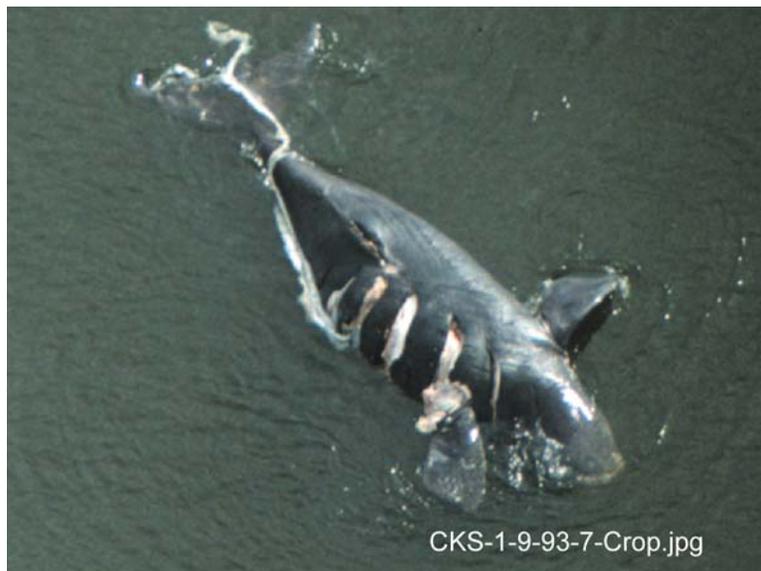
Aerial photographs of the carcass taken just before it was recovered (Figure-6) show the carcass floating ventral surface up. The cuts of Propeller Cut Series II are clearly visible along the animal's left side and across the ventral surface of the head. The shape and position of the cuts indicates that the animal was probably floating ventral surface up when the cuts were created. Since right whale carcasses usually float ventral surface up

Figure-6: Propeller Cut Series II – Aerial view of ventral surface shortly before recovery

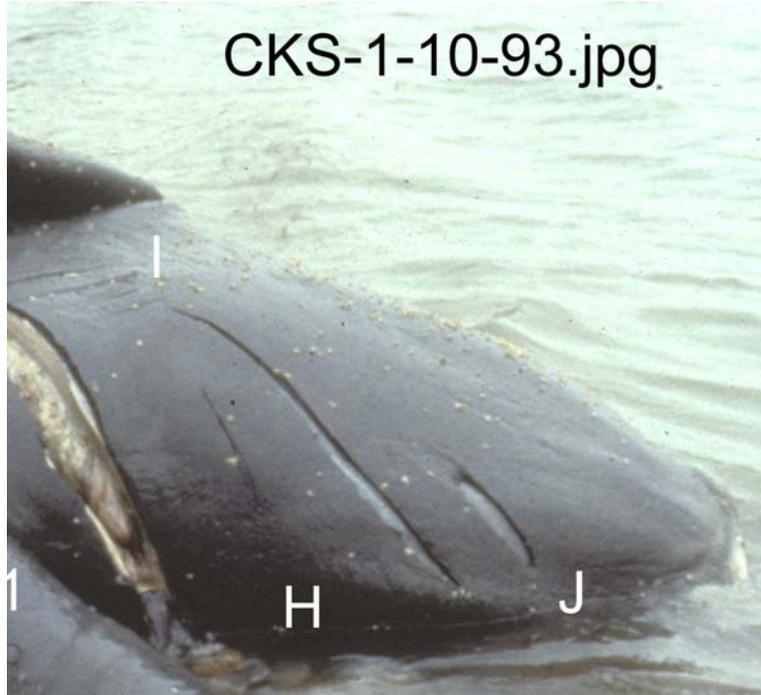
The general shape of the cuts gives the impression that the vessel approached the carcass from the animal's left rear (ventral surface up). The path of travel can be more conclusively established by examining the shapes of the very shallow cuts on the ventral surface of the head (Figure-7). Cut #I and Cut #J are very shallow cuts that were created by the very tip of the propeller blade. The crescent shapes of these cuts indicate the vessel's path was from the tail to the head (Figure-10). The shape and position of the cuts in Series II also indicate that the propeller was turning counter clockwise.

Cuts #I and #J also indicate that when the cuts in Series II were created the head of the animal was probably deeper in the water than the rest of the carcass. The caudal side of each of these cuts includes an area where the surface of the animal's skin has been shaved off by the propeller blade. This indicates that the surface of the animal was at a very acute angle to the blade of the propeller. The preceding cuts in the series are unremarkable in this regard and indicate that the surface of the animal was in the more common position which is essentially perpendicular to the blade. This may indicate that the carcass had not filled with enough gases from decomposition to allow the head to float at the same level as the remainder of the body. This information could be helpful in establishing when the collision that created Propeller Cut Series II occurred.

Figure-7: Propeller Cut Series II – The shape of very shallow cuts on a relatively flat surface can be used to determine the direction the vessel traversed the body. These cuts indicate the vessel traveled from tail to head.

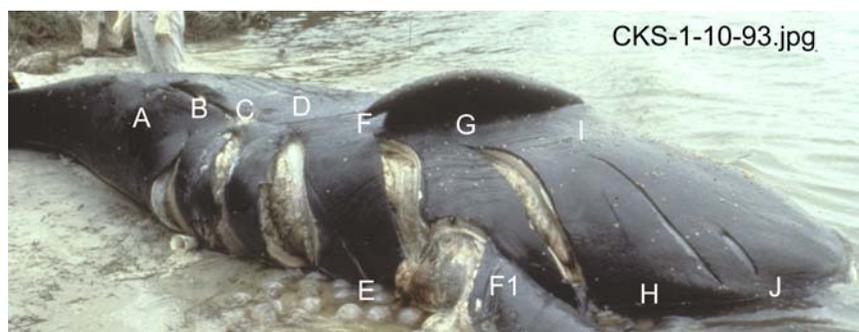
There is another anomaly in Propeller Cut Series II that is very curious. It appears that there may be two series of cuts superimposed one over the other (Figure-8). Cuts A, B, C, D, F, G, and I (referred to as Cuts A-I) are regularly spaced and of similar length and appearance. These cuts also appear to converge at a common point to the left of the vessel's relative path which would represent the center of a radius formed by the relative path of the vessel. Cuts E, F1, H and J (referred to as Cuts E-J) appear to form another series of cuts which more or less converge at a point opposite the center of radius for the other cuts. These cuts are also spaced at regular distances similar to the spacing of Cuts A-I.

Cut #E, which is not properly rendered in the necropsy drawing and is difficult to see in the photographs (Figure-8), is a very shallow cut which lies between two relatively deep cuts. It is also at a significantly different angle indicating that it does not share the radius common to most of Cuts A-I. For a propeller to create a relatively deep cut followed by a shallow cut which is then followed by another relatively deep cut on a fairly even surface would be very unusual. Yet, this accurately describes the relationship between cuts D, E, and F.

Figure-8: Propeller Cut Series II – Possibly two series of cuts overlying one another
