**Evaluation of Propeller Strike on Right Whale 2425 off Cumberland Island,  
Georgia on 10 March 2005**

**Draft – April 3, 2005**

**Evaluation of Sabreline 42 Express Propeller Strike on Right Whale 2425 off  
Cumberland Island, Georgia on 10 March 2005**

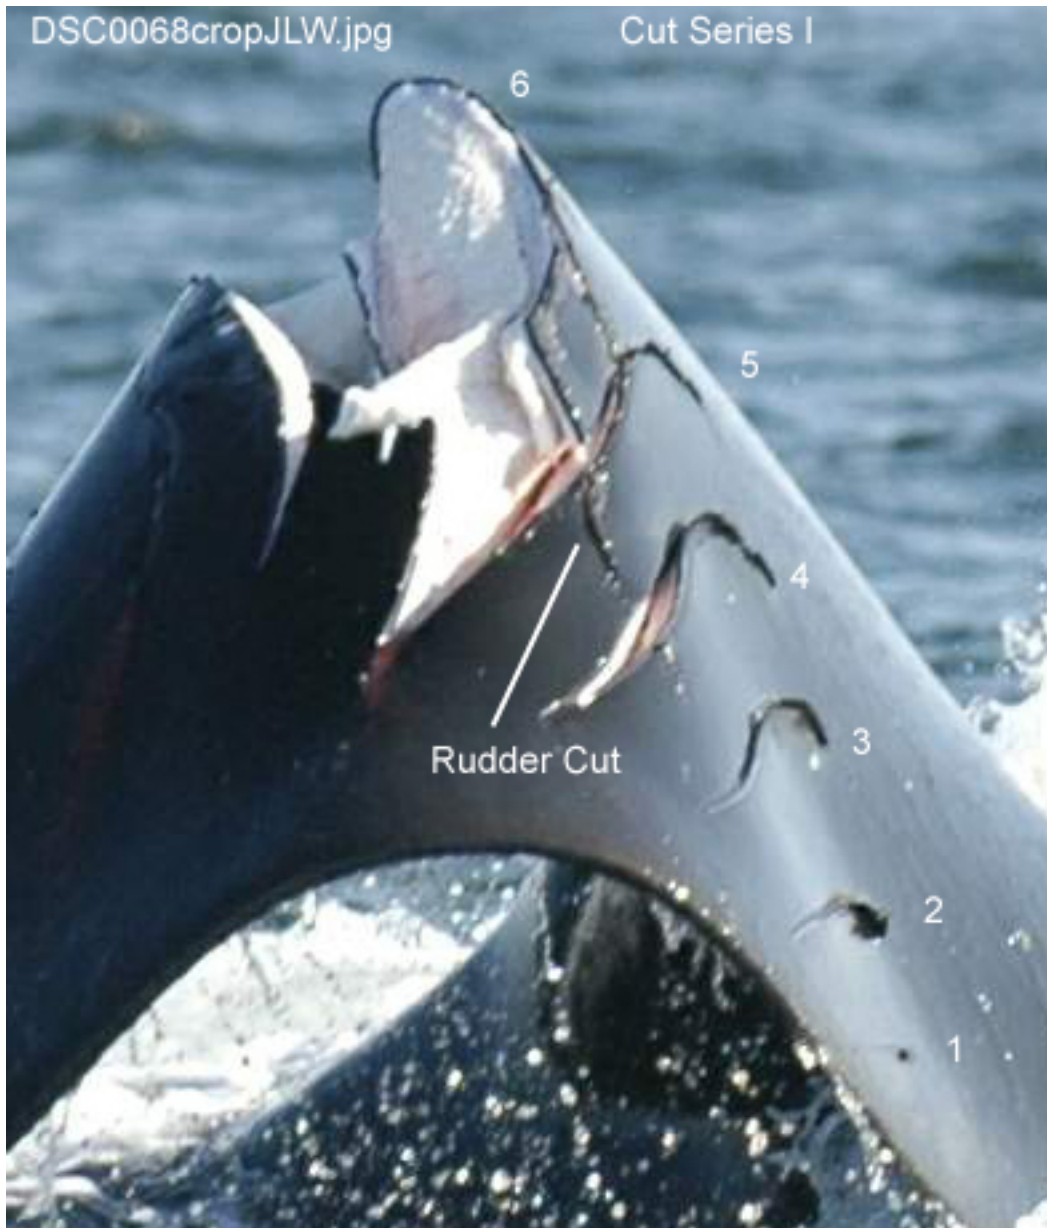
Figure 1: Cut Series I runs across the dorsal surface of the left fluke about 45° to the centerline of the animal's body.

These images showed six propeller cuts across the dorsal surface of the left fluke of a whale visible in Figure 1. This series of cuts was identified as Cut Series I. These cuts appeared to follow a track approximately 45° to the centerline of the animal. The first four cuts, beginning at the posterior edge of the fluke, did not appear to be very deep. The fifth cut in the series was significantly longer and appeared to be deeper than the initial four. The sixth cut appeared to be severe. It began on the anterior edge of the fluke and cut through the fluke’s dorsal and ventral surfaces for approximately one third of the distance from the anterior to posterior edges of the fluke. It then appeared to cut only through the dorsal surface of the fluke for an additional ten percent of that distance. The area between the fifth and sixth cuts was chaotic, and it was difficult to interpret the shapes of individual cuts in this area. The anterior third of the length of the first through the fifth cuts had a very distinct arch, and the skin along the margin of these cuts in the area of the arch was ragged. The remaining two thirds of the length of these cuts were relatively straight.

The six cuts in Cut Series I, clearly visible in Figure 1, form a track that runs approximately 45° to the centerline of the animal, and they exhibit an unusually exaggerated arch shape at the anterior end of the cuts. There is an additional cut that is essentially perpendicular to the individual propeller cuts and transects the fourth, fifth and sixth cuts in the series. This cut was created by a free standing rudder positioned just aft of the propeller. Between the fifth and sixth cuts, the cut created by the rudder penetrated through the surface layers of tissue and allowed these layers of tissue to separate from the underlying tissue. This created a chaotic pattern in this region which makes the shapes of these cuts difficult to identify.

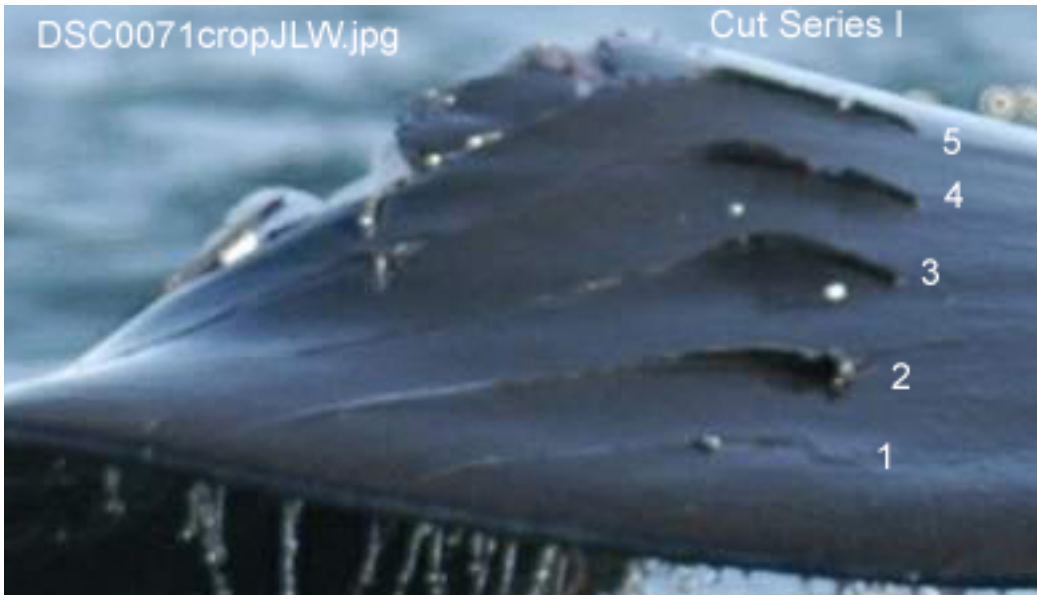
Figure 2: A view of Cut Series I viewed at an oblique angle to the surface of the fluke. Cut #2 is the primary focus of analysis using this image.

Cut #2 in Figure 2 was selected as the primary subject of the analysis. Though the camera position for this photograph is not perpendicular to the surface of the fluke, it is approximately in line with the centerline of the track of the cuts in Cut Series I. The oblique angle of the lens axis may limit the accuracy of the calculated results. The calculations performed on this series of cuts provided the following possibilities for the propeller that may have created the cuts:

It was also determined that this propeller was rotating counter clockwise and was probably the port propeller. The advance coefficient for this cut series was calculated to be 1.05.

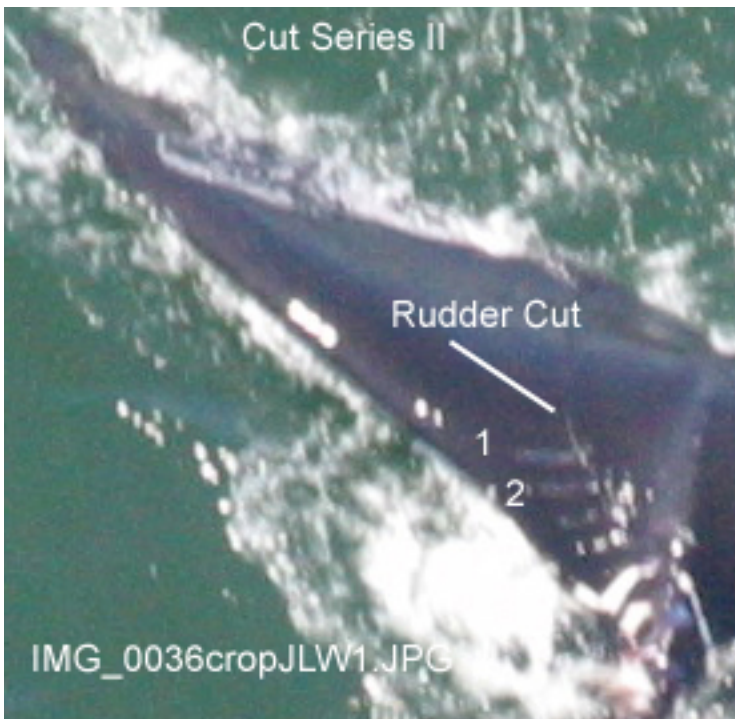
Figure 3: A view of Cut Series II from slightly anterior of perpendicular. Cut #2 is the primary focus of the analysis using this image. The limited resolution made it difficult to accurately identify the end points of the cuts.

The cuts in Cut Series II are visible in Figure 3 and Figure 4. Both of these photographs are aerial views taken almost perpendicular to the surface of the fluke. Figure 3 is a view slightly anterior of perpendicular, and Figure 4 is a view slightly posterior of perpendicular. The resolution of these images limited the author's ability to precisely

The cuts in this series begin along the anterior end of the right side of the fluke and track across the base of the peduncle. The cuts were created by a propeller rotating clockwise which was probably the starboard propeller. A cut from a free standing rudder positioned behind the propeller is also clearly visible in Figure 3.

Cut #2 was selected as the primary subject of the analysis in Figure 3. The calculations performed on this series of cuts provided the following possibilities for the propeller that may have created the cuts:

It was also determined that this propeller was rotating clockwise and was probably the starboard propeller. The advance coefficient for the cut series, as viewed in this photograph, was calculated to be 0.80.

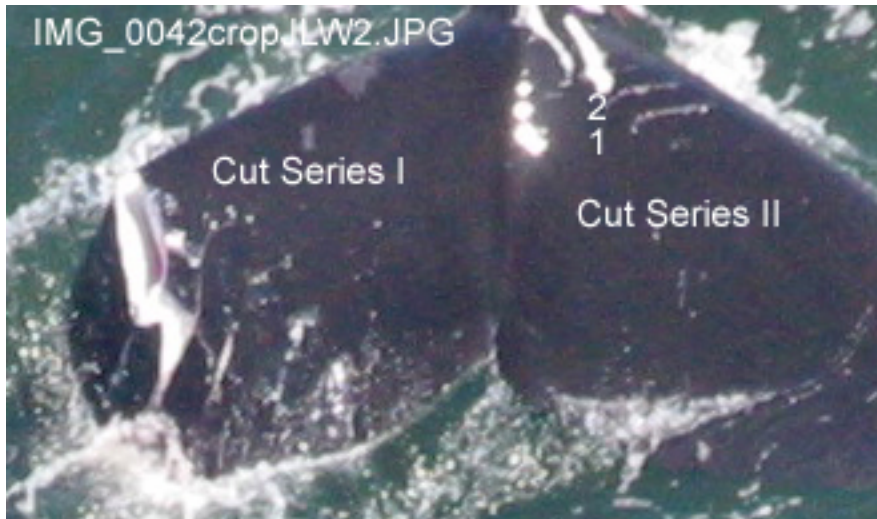
Figure 4: A view of Cut Series II from slightly posterior of perpendicular. Cut #1 is the primary focus of the analysis using this image. The limited resolution made it difficult to accurately identify the end points of the cuts.

Cut #1 was selected as the primary subject of the analysis in Figure 4. The calculations performed on this series of cuts provided the following possibilities for the propeller that may have created the cuts:

It was also determined that this propeller was rotating clockwise and was probably the starboard propeller. The advance coefficient for the cut series, as viewed in this photograph, was calculated to be 0.90.

The difference in the calculated values for these two Figures very probably results from inaccuracies in locating the end points of the individual cuts.

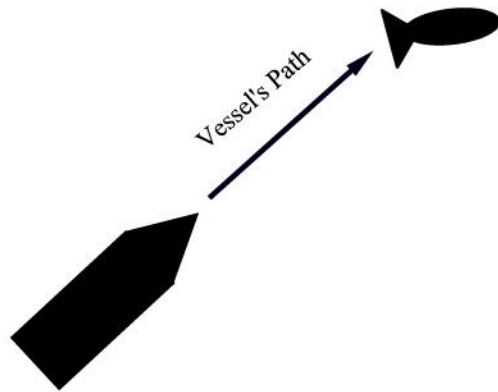
Probable Approach at First Contact

Note: The vessel approached from the whale's right rear quadrant.

Figure 6: The vessel approached from the whale's right rear quadrant.

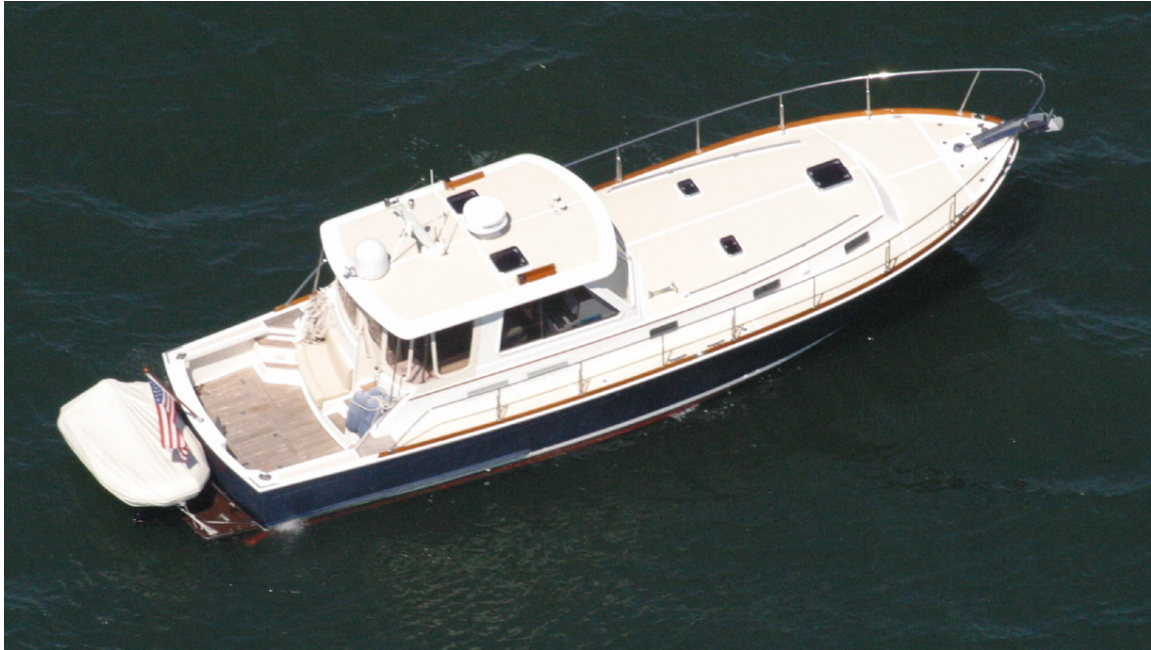
Figure 7: The vessel alleged to be involved in the accident.

Once all of the calculations for this evaluation were complete, the author was provided a photograph of the vessel alleged to be involved in the accident (Figure 7). Since the incident was still under investigation, specifics regarding the vessel were not available. All specifics presented here are based on the assumption that the vessel shown in the photograph was involved in the accident, and were developed by the author from sources not involved in the investigation. Once the investigation is complete and the related information is available, this evaluation will be modified accordingly.

The vessel shown in the photograph was identified as a Sabreline 42 Express Cruiser. The manufactures specifications for this vessel indicate that it is 42 feet 3 inches in length with a beam of 14 feet 4 inches. It is normally equipped with twin 4 blade 26 inch diameter propellers and with either 450 hp Cat engines with a 2.000:1 gear ratio and propellers with 31 inch pitch or 500 hp Yanmar engines with a 2.227:1 gear ratio and propellers with 35 inch pitch.

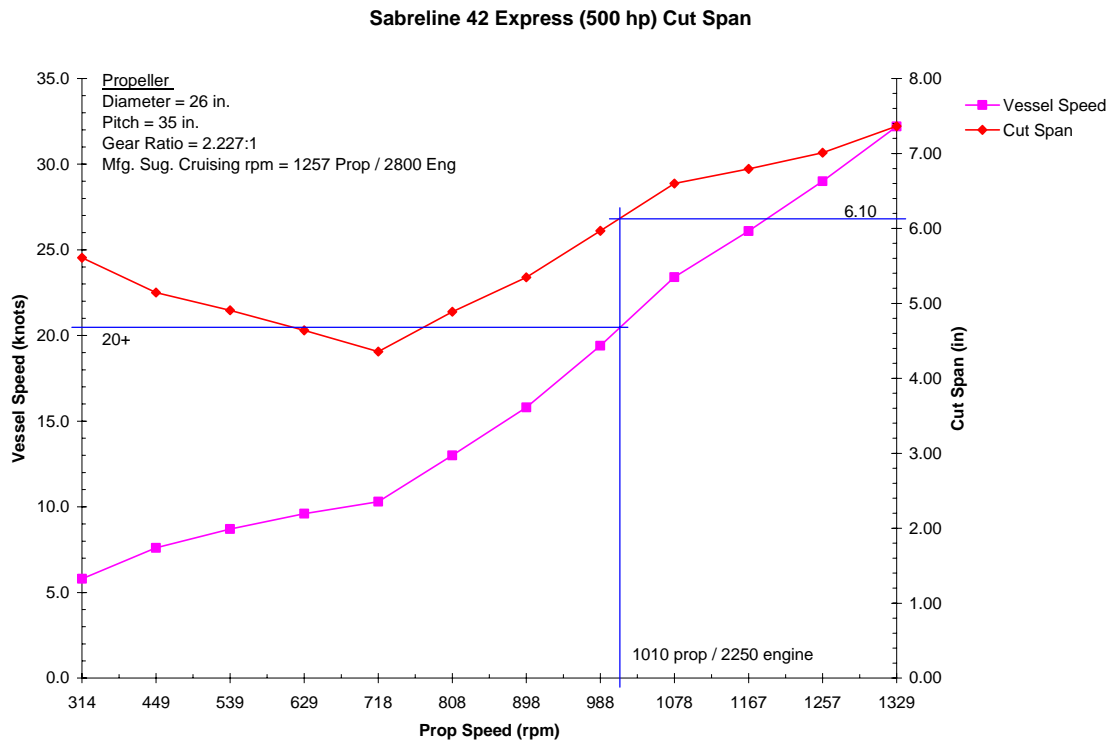
Figure 8: The average cut span of 6.10 inches indicates that the vessel, equipped with a 500 hp engine, would be traveling at slightly over 20 knots with a propeller speed of 1010 rpm (2250 engine rpm).

The manufacture also provides tables of performance data for vessels equipped with both engines. This data was used to prepare charts for translating values calculated from the propeller cuts into vessel operation values. For convenience, only charts for the 500 hp engines are reproduced here. The chart in Figure 8 uses the average cut span of 6.1 inches to determine that the vessel was probably traveling at just over 20 knots with a propeller speed of 1010 rpm (2250 engine rpm). The chart in Figure 9 uses the advance coefficient of 0.92 to determine that the vessel was probably traveling at just under 20 knots with a propeller speed of 990 rpm (2205 engine rpm). These values were averaged to a vessel speed of 20 knots with a propeller speed of 1000 rpm (2227 engine rpm). In the chart in Figure 10 uses the averaged vessel speed of 20 knots to determine that the propeller slip was about 30%, and the propeller advance was 24.5 inches per revolution. The advance coefficient calculated from the averaged vessel operation values is 0.94.

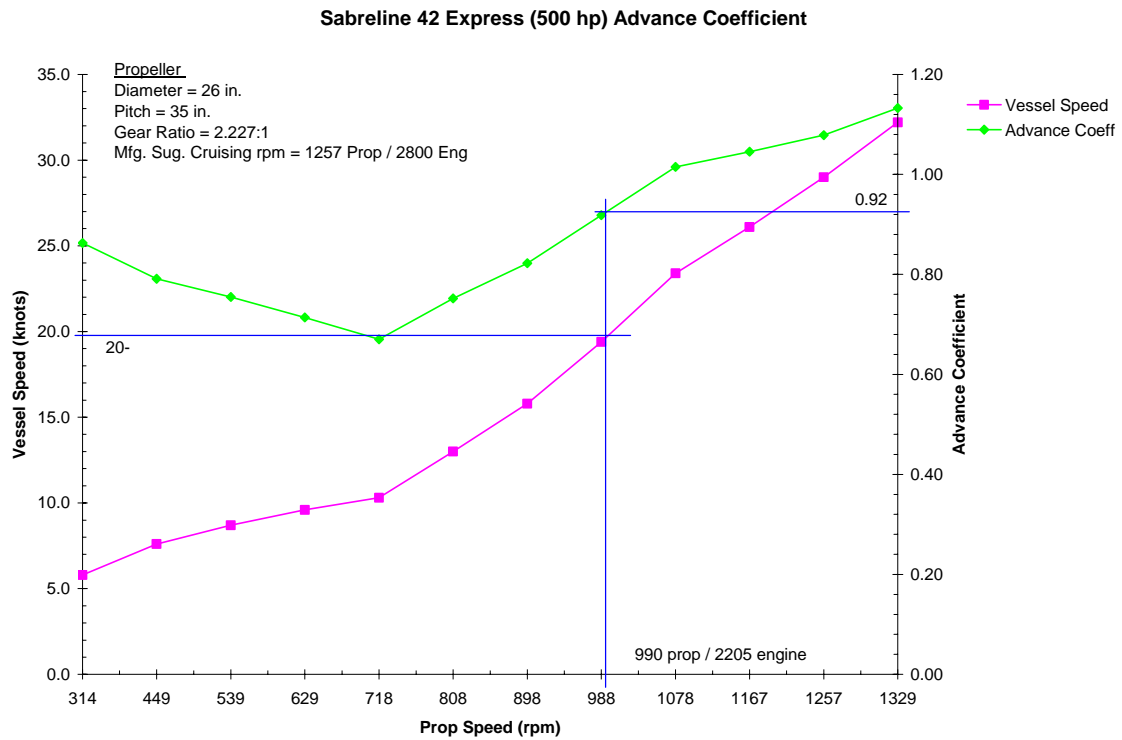
Figure 9: The advance coefficient of 0.92 indicates that the vessel, equipped with a 500 hp engine, would be traveling at slightly under 20 knots with a propeller speed of 990 rpm (2205 engine rpm).

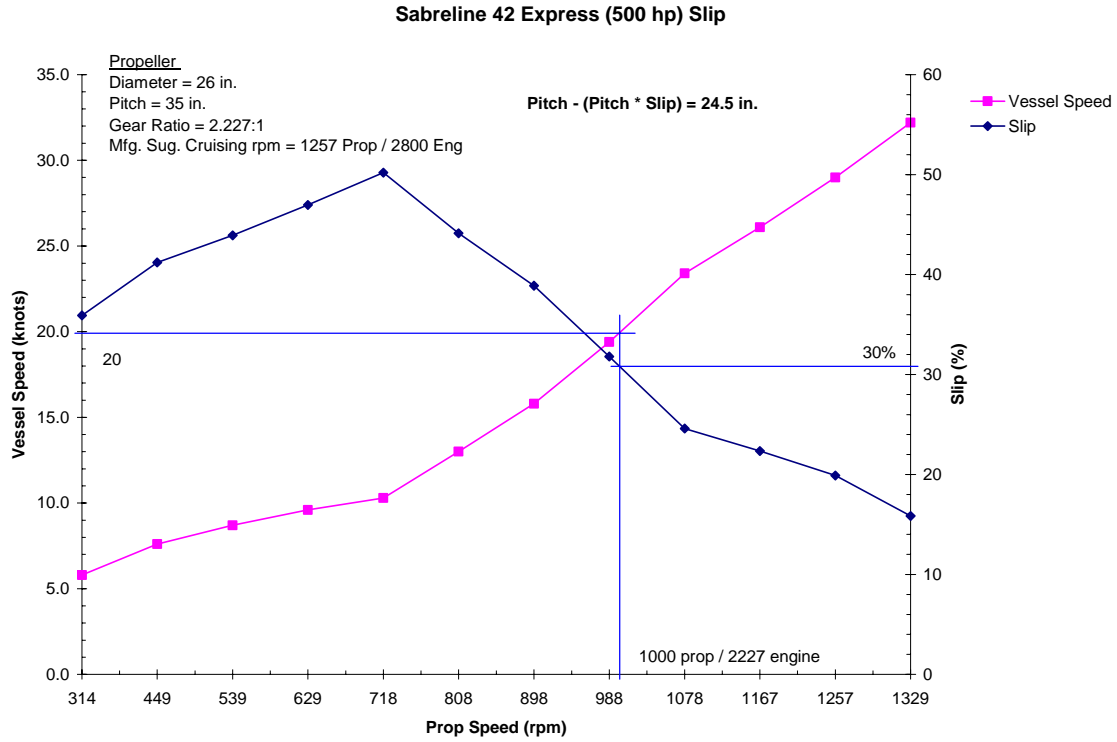
Figure 10: The speed of 20 knots indicates that the vessel, equipped with a 500 hp engine, would be operating with about 30% slip, and the propeller would advance 24.5 inches per revolution.
