Evaluation of Propeller Cuts Documented in Right Whale Necropsy

Field No.: DVS 2006-04745

**James L. Wood
Lumatrex, Inc.**

August 31, 2006

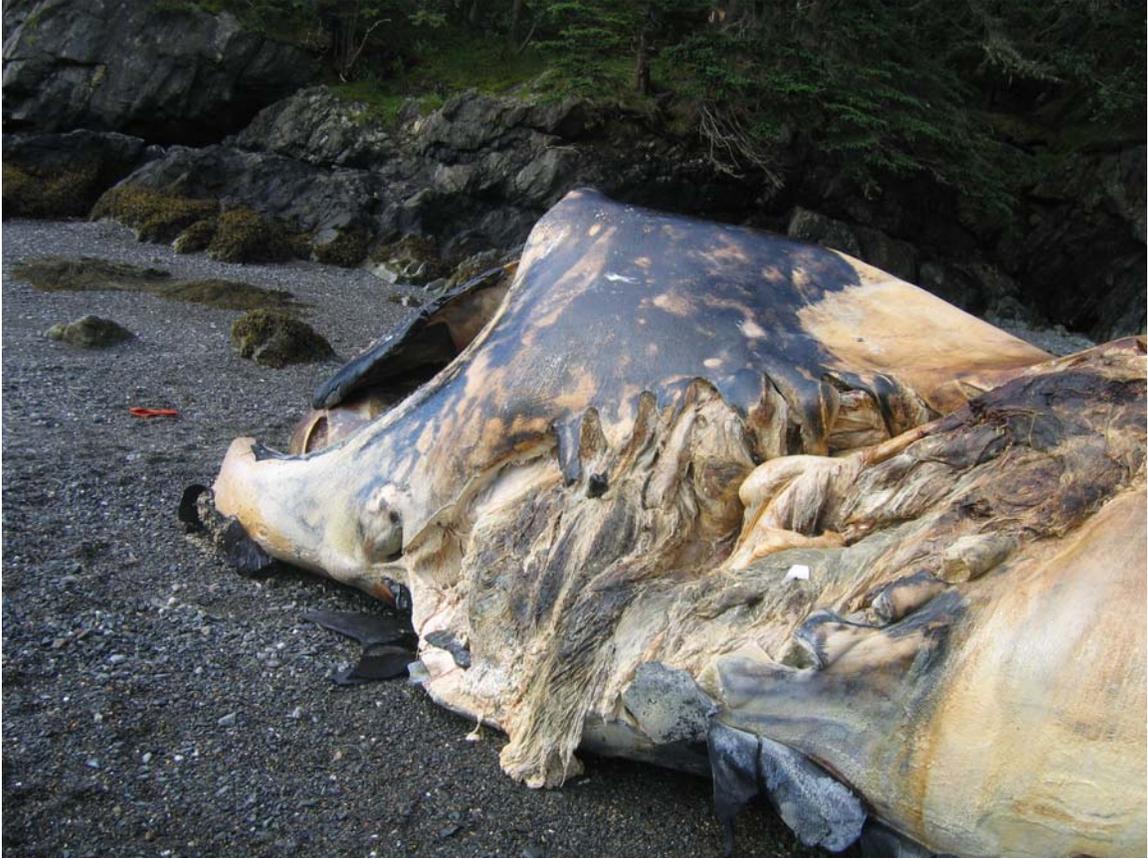
Photo 1: Propeller Cuts - In Situ (IMG_1304.JPG)

1. This was a significant strike with deep propeller and rudder cuts.
2. The longest cut in the series, Cut #7, was approximately 61 cm (24 inches) long, which establishes that the propeller must have been at least 25 inches in diameter.

4. A cut running the length of the cut series transects cuts #4 through #10 but not cuts #1 through #3 or cuts #11 through #13. This indicates that this cut was probably created by an unsupported rudder positioned behind the propeller. Also, the bottom edge of the rudder was probably positioned above the lowest point of the propeller's rotation. This is also characteristic of an unsupported rudder.

6. The cut spans for the two sets of measurements of cuts #1 through #9 vary widely. The cut spans measured in situ for this region range from 5.5 inches to 10 inches. The type of vessel indicated by all of the other data will not normally create cut spans greater than 6.5 to 7 inches. Also, the photos of the carcass illustrate the difficulty of taking in situ measurements in this region of the cuts. Therefore, the in situ cut span measurements cannot be considered very reliable. The measurements of cut span in this region taken after the blubber layer was removed are more consistent with the other data.

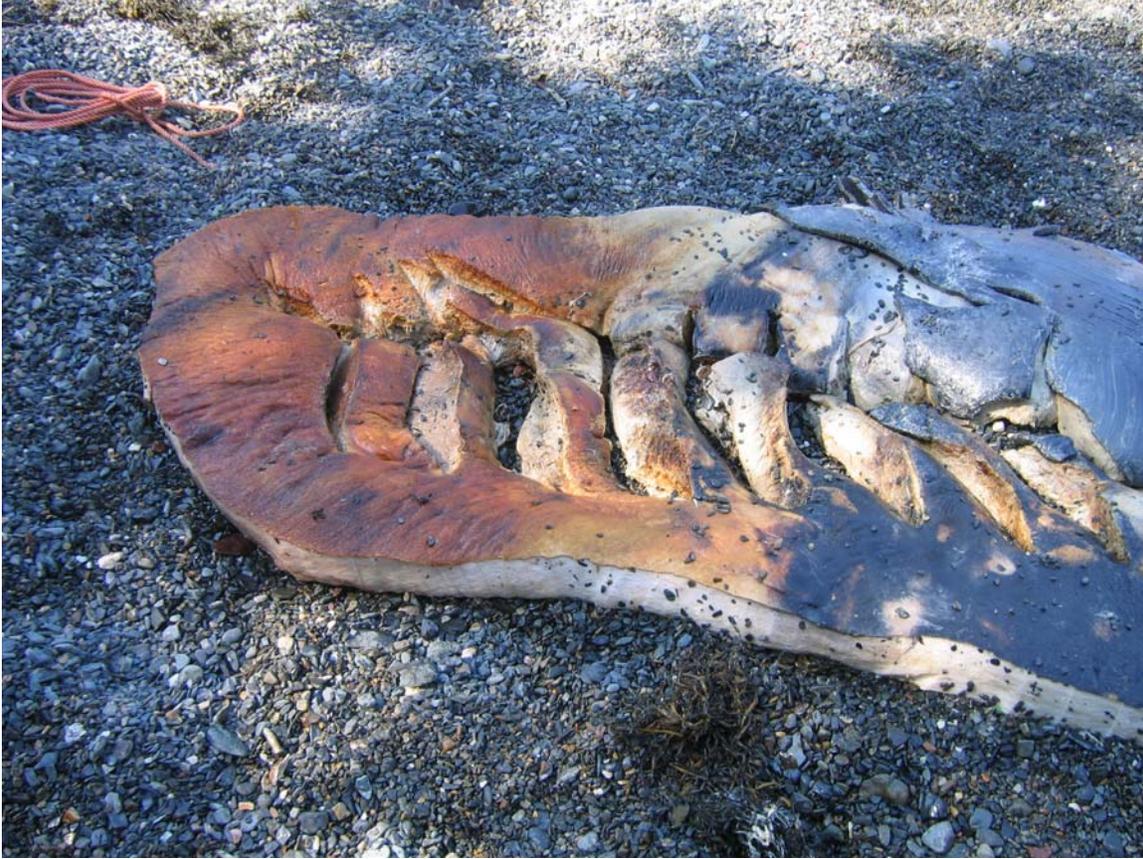
Photo 2: Cut #1 is to the left. (Whale Necrop 2006 - 26.JPG)

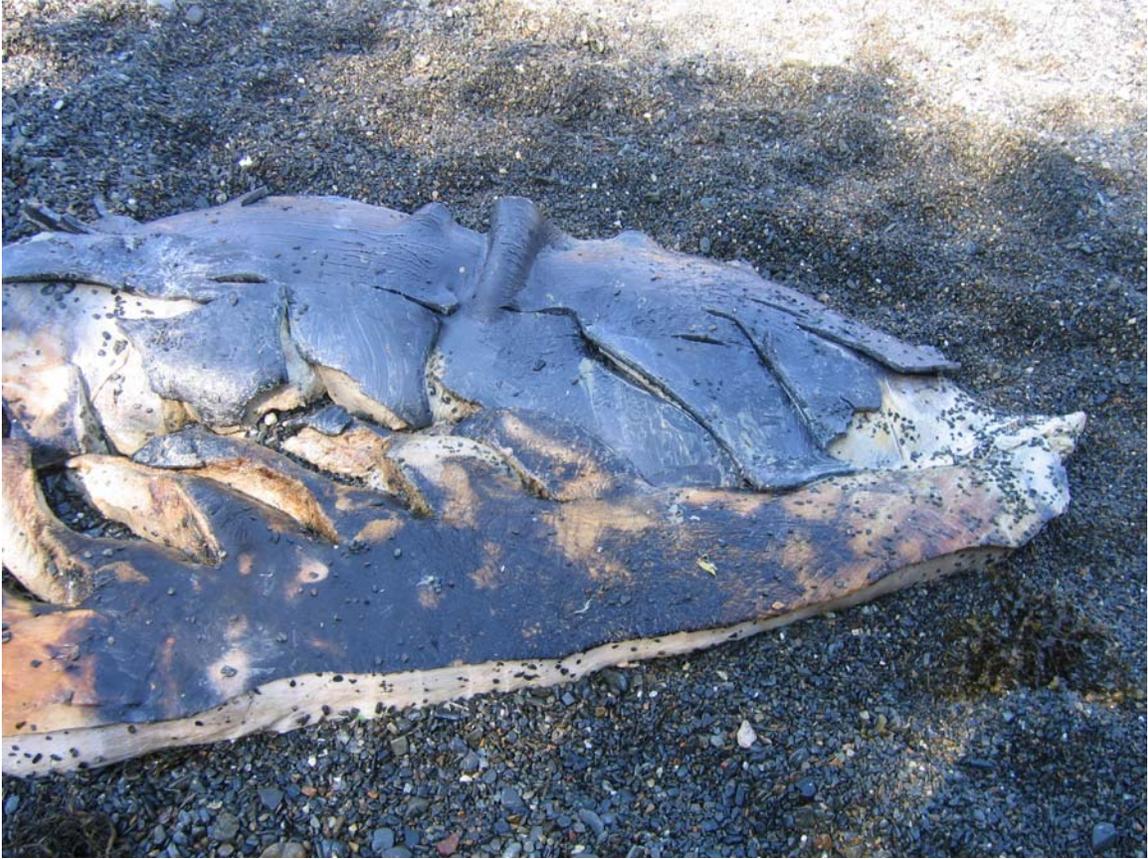
Photo 3: Cut #13 is to the right. (Whale Necrop 2006 - 27.JPG)

7. If the animal was "upright" in the water when it was struck, the deepest cuts should occur near the animal's dorsal midline at the approximate position of cut #13. Also, there would probably be cuts on either side of the midline. The deepest cut, #7, is positioned approximately halfway between the animal's dorsal midline and its right lateral line, and none of the cuts occur on the left side of the animal's dorsal midline. This would indicate that the animal was positioned slightly on its left side with its upper right quadrant nearest the surface when it was struck.
